Manhole Inspection Summary

Manhole # S19K__024MH

Insp Date: **8/10/09 9:53 AM**

Location Address: **2018 FREDERICK-PRATT**

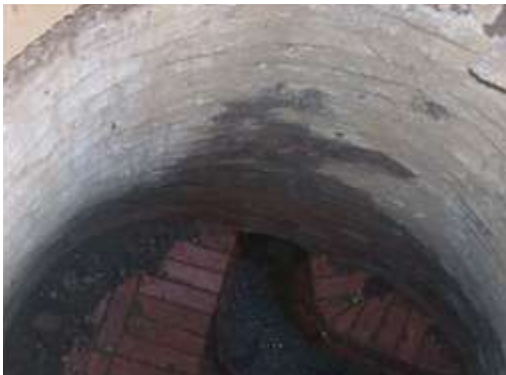
Defect 2

Infiltration: ☐ None ☐ Joint ☐ Cracks ☐ Mortar ☐ Roots ☒ **Wall**

CORBEL INFILTRATION

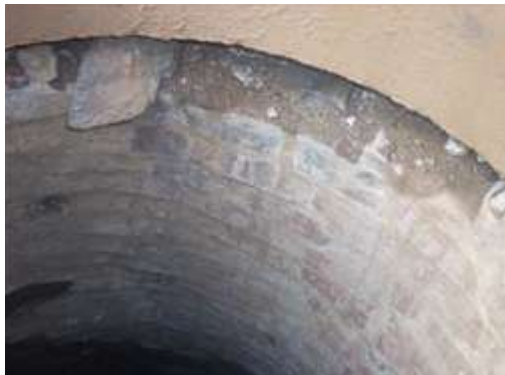
Defect 1

Condition: ☐ Sound ☐ Cracked ☐ Root Intrusion ☐ Loose Brick ☒ **Deteriorated**

CORBEL DETERIORATION

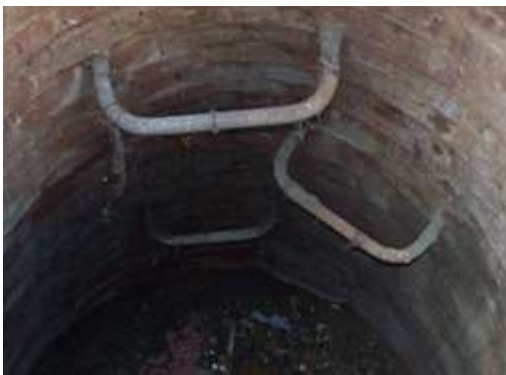
Defect 3

Surcharge ☐ Evidence Of Surcharge Depth: **1** (ft.) ☐ Active Surcharge Present

EVIDENCE OF SURCHARGE

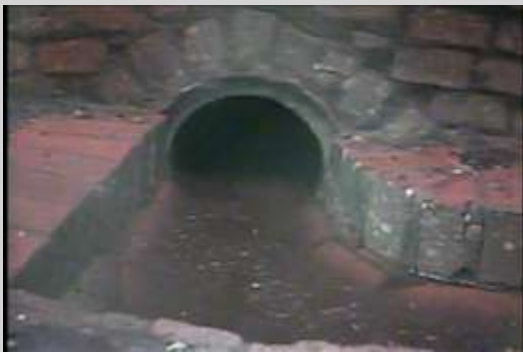
12 O'Clock Outflow

8 in. Circular Gravity Sewer
Pipe Out @ 12 O'Clock

Pipe Height: **8.4** (in.) Rod and Bar (Angled)
Pipe Material: **Clay** ☐ Pipe Lined
Invert Depth: **7.60** (ft.) Flow Characteristics: **None**
Deposits: ☐ None ☐ Mud ☒ **Grassy** ☐ Debris ☐ Grease
Silt Depth: **2** (in.) Deposits Extent: **Light**
Infiltration: **None** Pipe Seal Cond: **Sound**

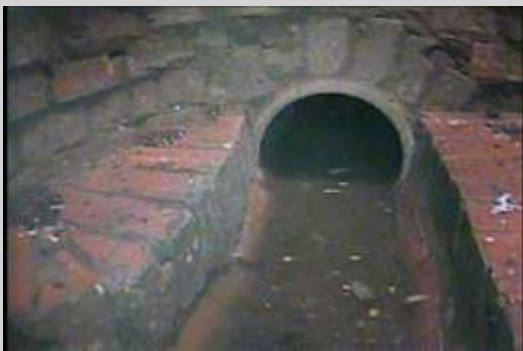
3 O'Clock Inflow

8 in. Circular Gravity Sewer
Pipe In @ 3 O'Clock

Pipe Height: **7.2** (in.) Rod and Bar (Angled)
Pipe Material: **Clay** ☐ Pipe Lined
Invert Depth: **7.49** (ft.) Flow Characteristics: **None**
Deposits: ☐ None ☐ Mud ☒ **Grassy** ☐ Debris ☐ Grease
Silt Depth: **2** (in.) Deposits Extent: **Light**
Infiltration: **None** Pipe Seal Cond: **Sound**
